**Transforming Construction with Reality Capture Technologies:  
The Digital Reality of Tomorrow**August 23-25, 2022, Fredericton, New Brunswick, Canada

**GEOMETRIC SURVEY THROUGH LASER SCANNING OF A HISTORICAL  
BUILDING IN ALBERTA**Burzic, E<sup>1\*</sup>, Iskander, G<sup>1</sup>, Duncan, N<sup>1</sup>, Shrive, N<sup>1</sup><sup>1</sup> Department of Civil Engineering, University of Calgary, Canada\* [emina.selman@ucalgary.ca](mailto:emina.selman@ucalgary.ca)

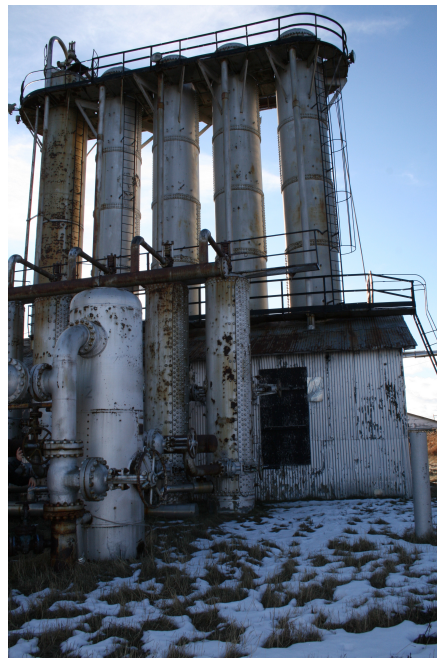
Figure 1: Exterior view of the absorption building located at the Turner Valley Gas Plant. The image shows the five absorption towers, and the corrugated iron sheathing. (Parks Canada Agency.1995)

The absorption building consists of a steel frame with corrugated iron sheathing built on a concrete foundation, as shown in Figure 1 (Turner Valley Gas Plant National Historic Site of Canada.2020). The columns and girders of the frame are historical pipe, while the beams are historical angles (Turner Valley Gas Plant National Historic Site of Canada.2020), as shown in Figure 2. The connections between members vary from welds to ties and pin connections. Through the middle of the building stand 5 absorption

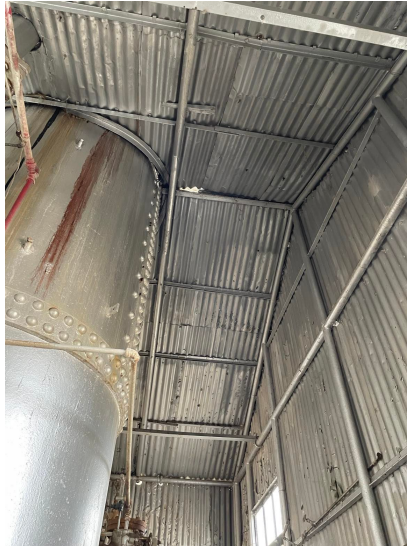
Figure 2: Interior view of the absorption building, depicting the various connections and types of members, alongside the vaulted ceiling and absorption tower.

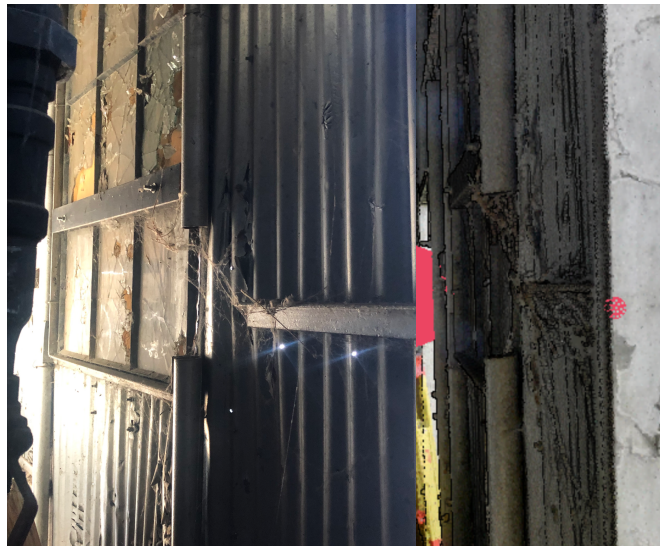
Figure 3: Photo and MiraCAD model comparison of the interior view of the absorption building, depicting a member that was manipulated to meet the demands of the oil and gas piping.

tanks, which have a diameter of 1 meter; these tanks obscure the view of the roof members and trusses. In addition to the obscured view, the absorption building has vaulted ceilings and many missing or deformed components which can be hard to keep track of, as shown in Figure 3. The building is 6.1 meters wide and 13 meters long. Within this condensed space the use of a ladder was limited to reach members; a more convenient, non-invasive alternative was needed.
